**REMOVAL PROGRAM  
AFTER ACTION REPORT  
FOR THE  
ALLIED PLATERS SITE  
HARTFORD, HARTFORD COUNTY, CONNECTICUT  
26 SEPTEMBER 2013 THROUGH 6 JANUARY 2014**

U.S. Environmental Protection Agency  
Region I  
Emergency Planning and Response Branch  
5 Post Office Square, Suite 100  
Boston, Massachusetts 02109-3912

Weston Solutions, Inc.  
Superfund Technical Assessment and Response Team III (START)  
3 Riverside Drive  
Andover, Massachusetts 01810

February 2014

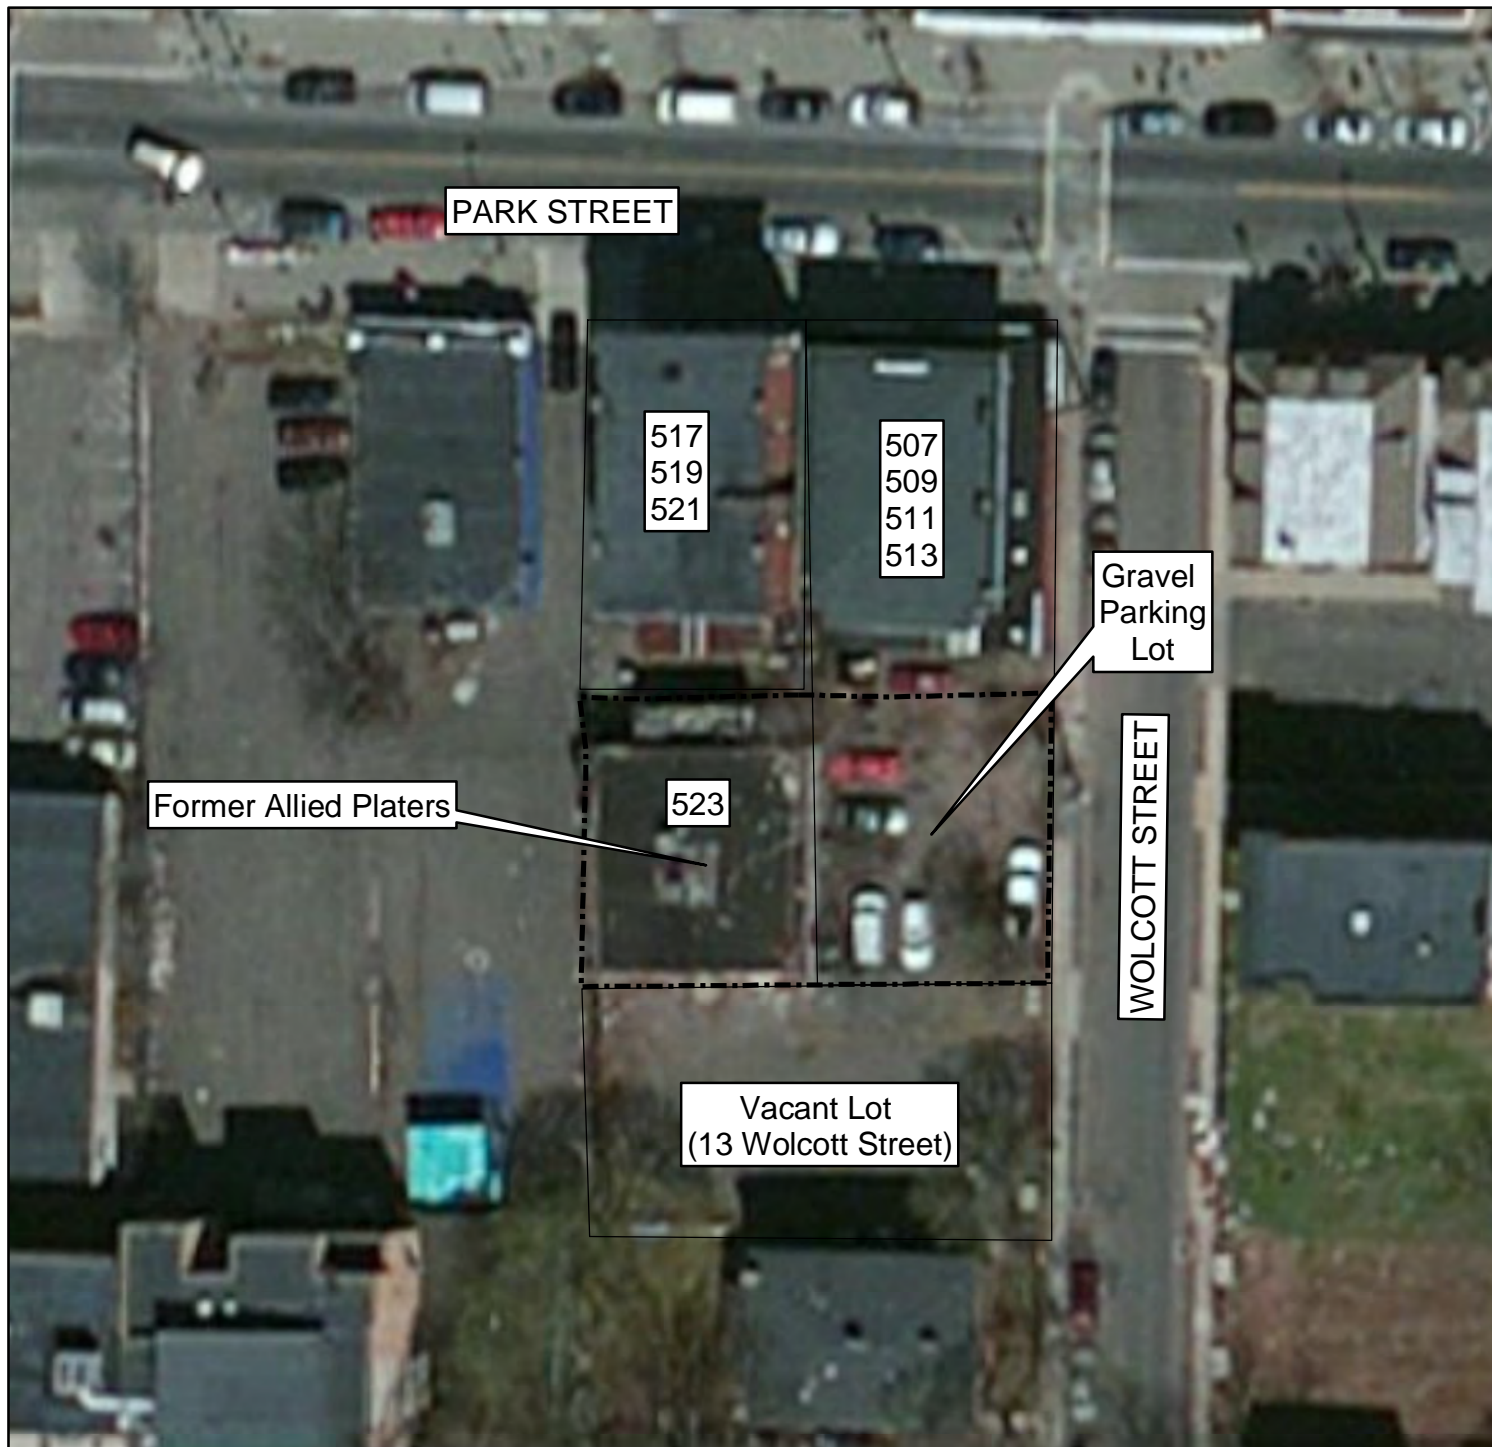
**Figure 2**

**Site Diagram**

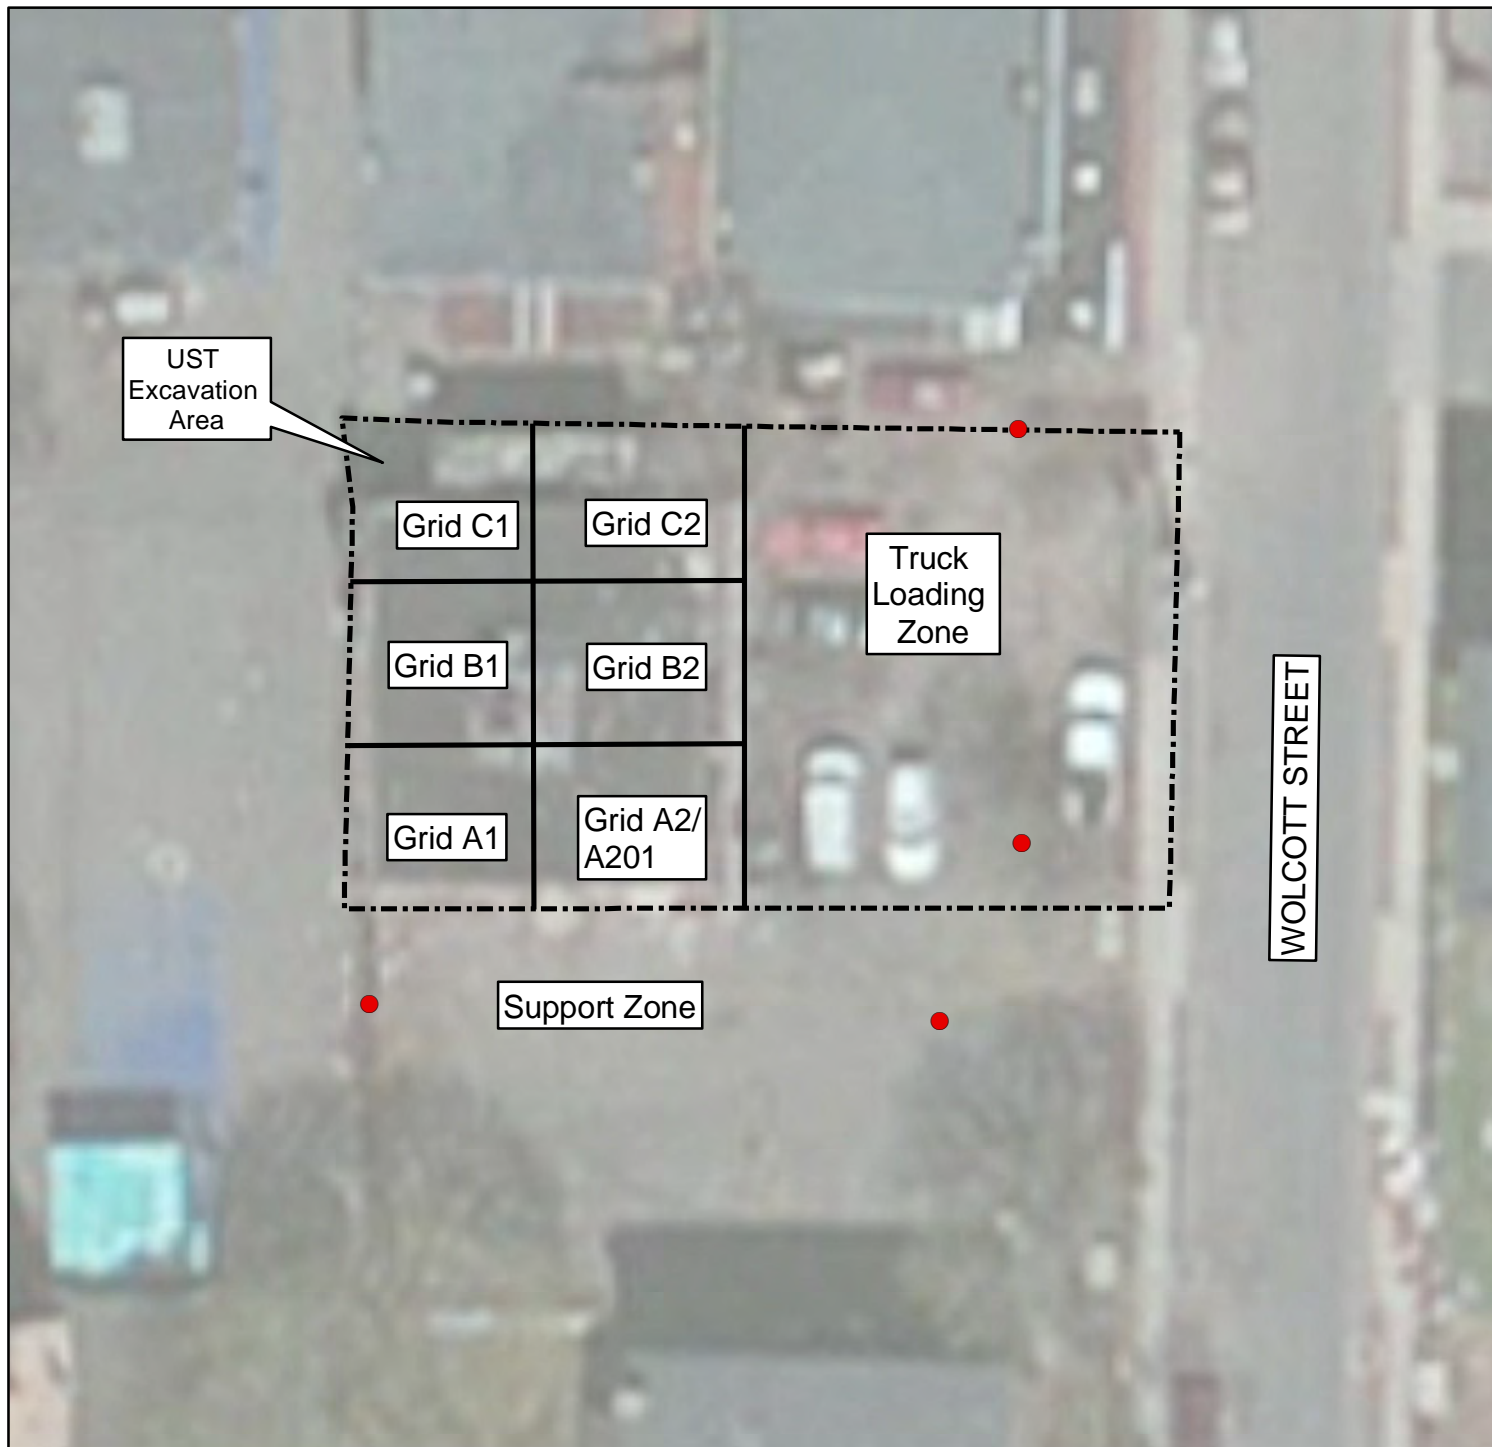
**Figure 3**  
**Post-Excavation**  
**Soil Sample Location Map**  
**Allied Platers**  
**523 Park Street**  
**Hartford, Connecticut**

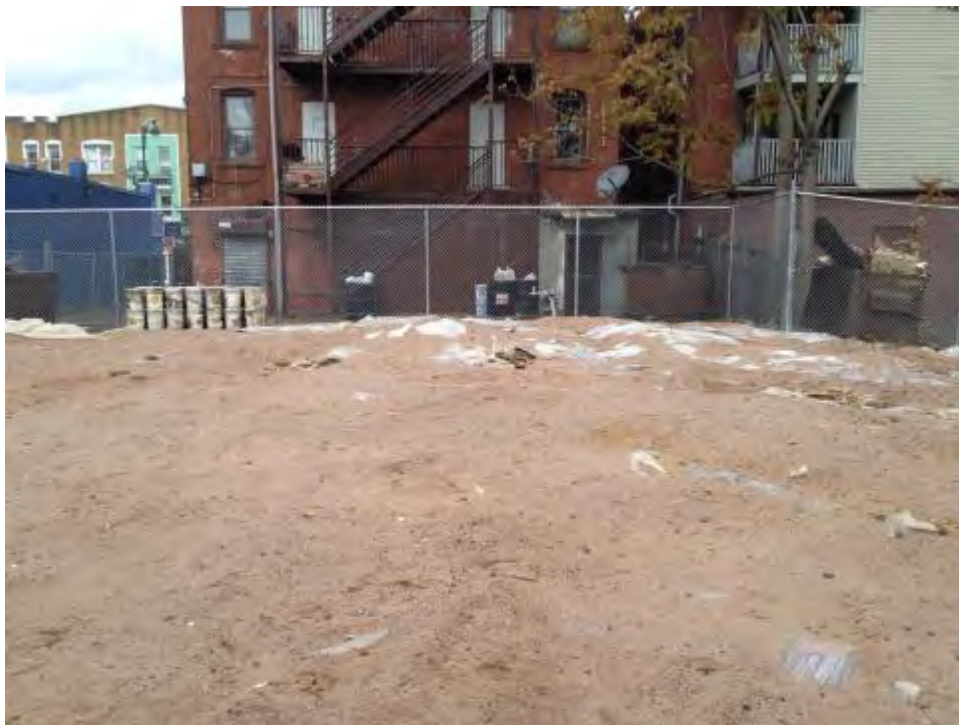
**SCENE:** View of the Allied Platers site prior to Removal Action activities. Photograph taken facing north.

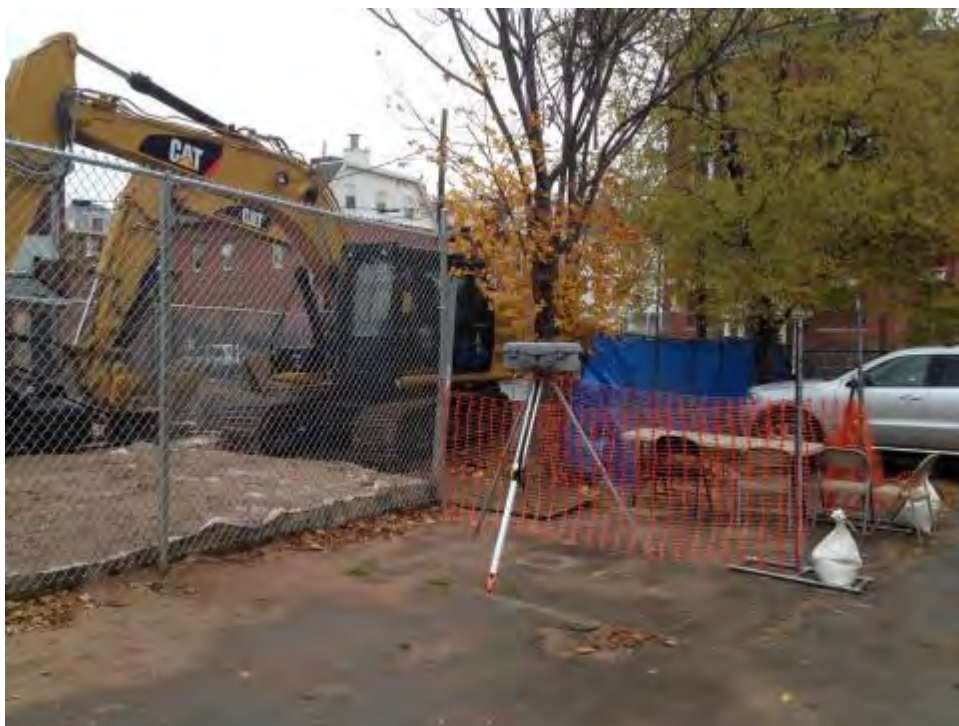
**SCENE:** View of the support zone and a Dustrack particulate aerosol monitor. Photograph taken facing east.

For the duration of removal activities, START Site Leader (SL) Saylor used DustTrak particulate monitors to conduct perimeter air monitoring, and photodocumented removal activities (see Appendix C, Photodocumentation Log). In addition, the ERRS crew secured the excavated soil piles with polyethylene liners at the end of each day.

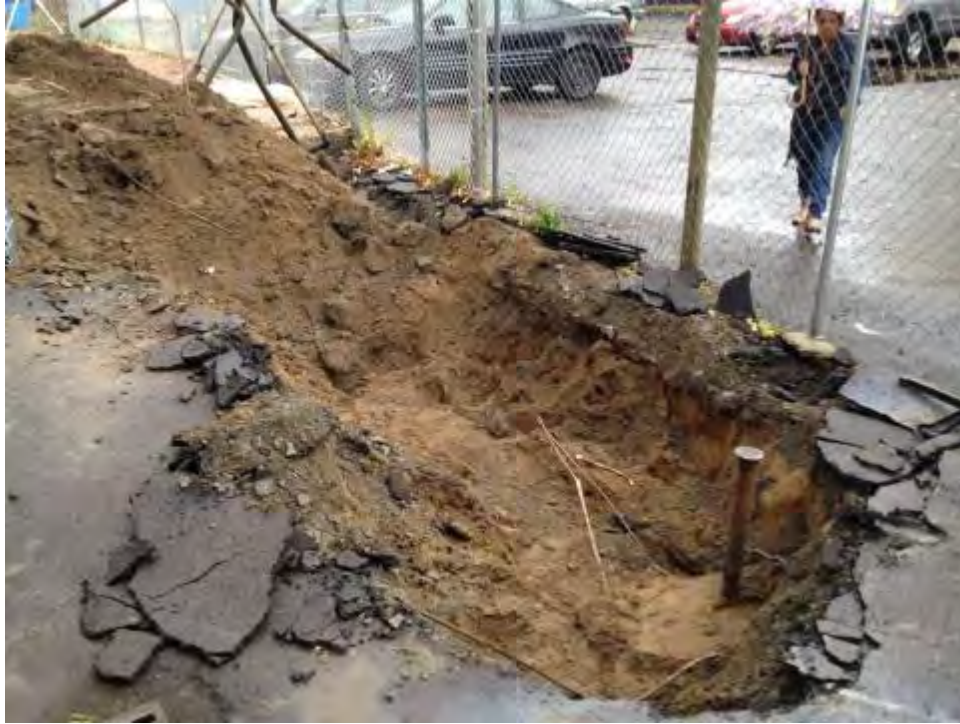
**SCENE:** View of the excavation of the underground storage tank (UST) from the northwest portion of the site. Photograph taken facing southwest.

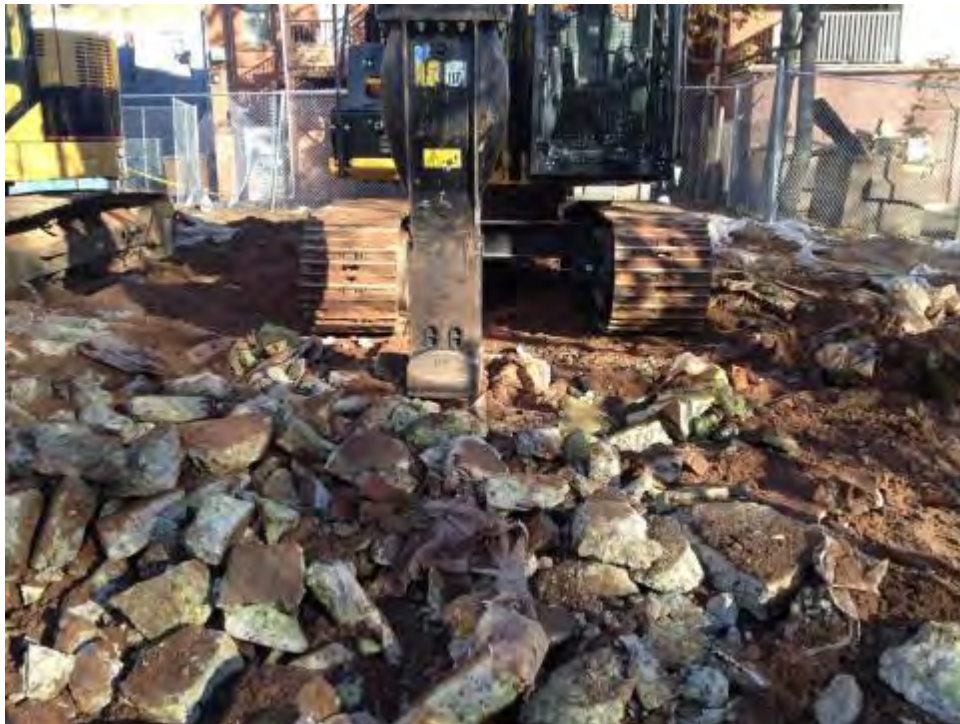
**SCENE:** View of the exclusion zone with demolished concrete foundation and green staining. Photograph taken facing north.

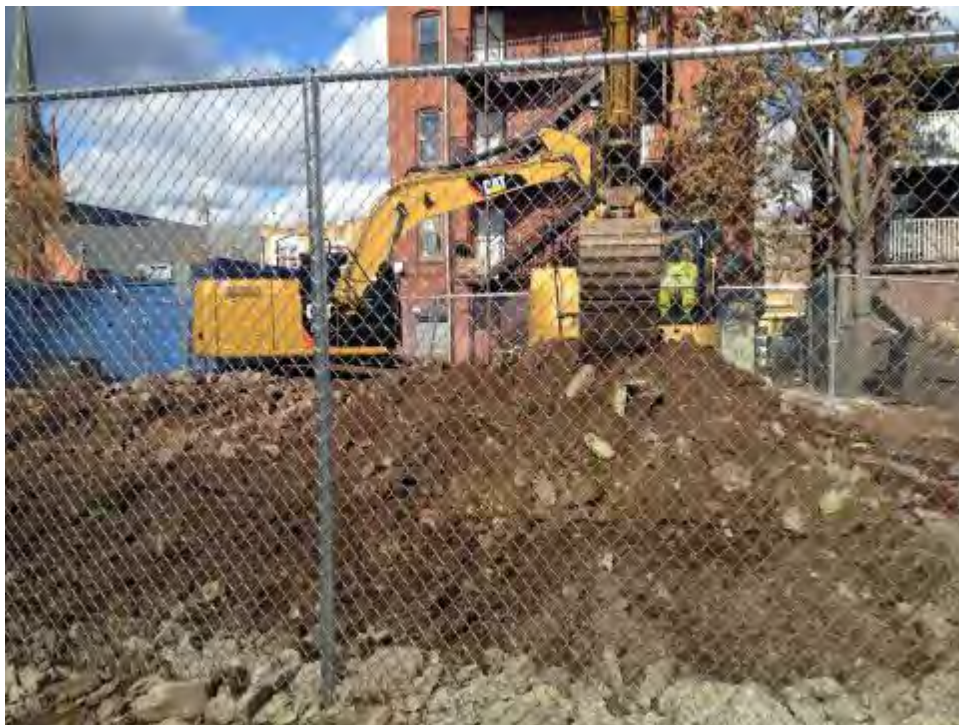
**SCENE:** View of the exclusion zone with demolished concrete foundation and a stockpile of excavated contaminated material. Photograph taken facing northwest.

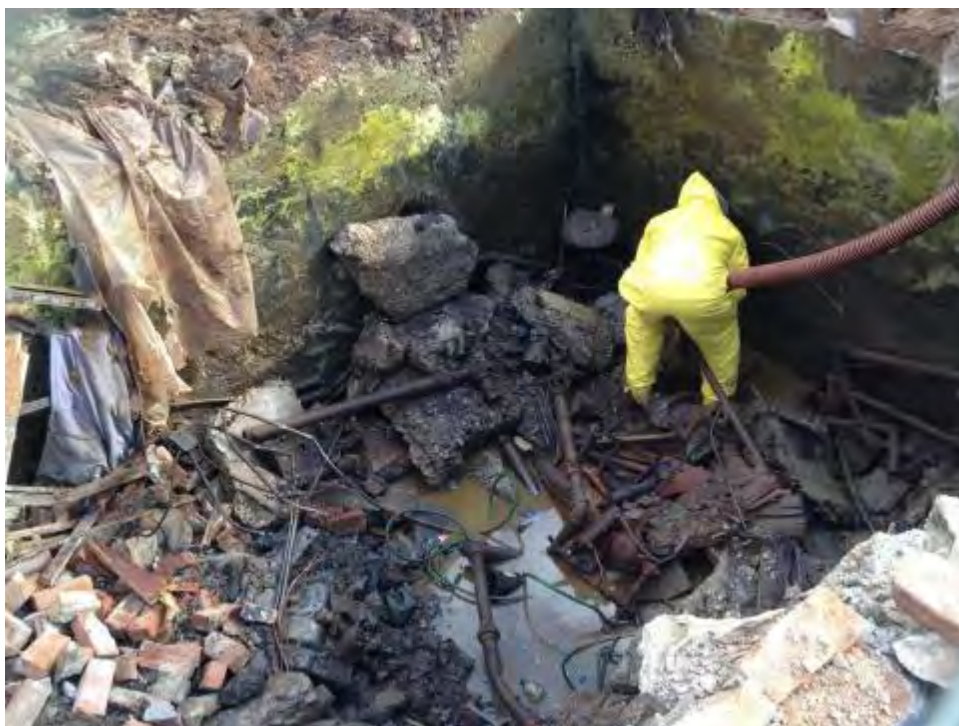
**SCENE:** View of the sub-floor area filled with boiler room debris and green staining on the walls.

On 8 November 2013, a truck from Tradebe Treatment and Recycling was on site to pump a total of 1,464 gallons of contaminated water from the sub-floor area of the former building.

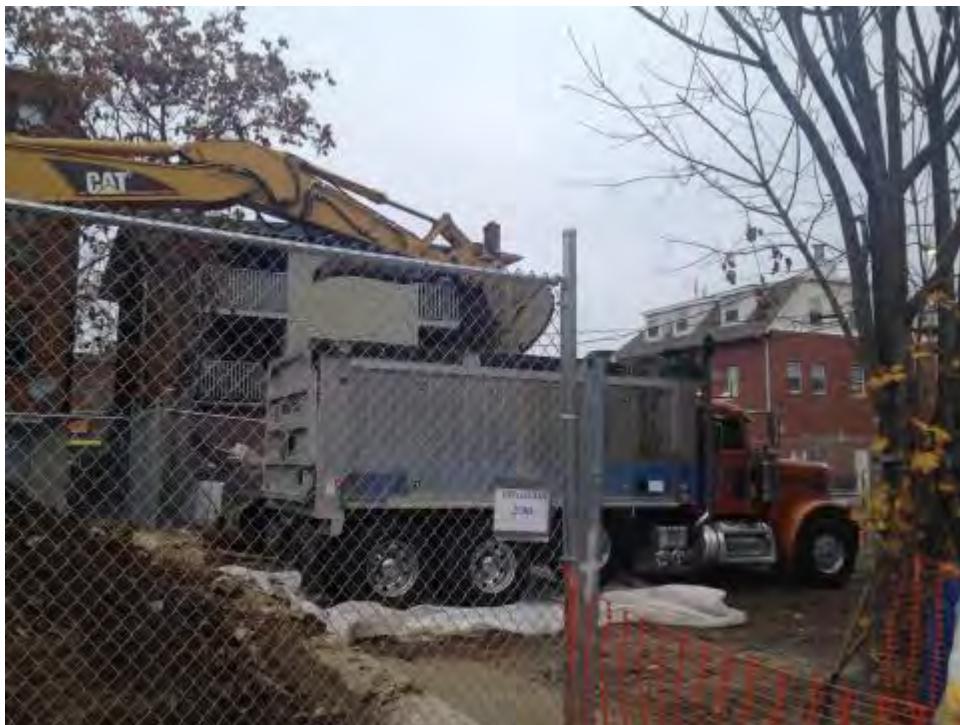
**SCENE:** View of the loading of excavated soil for transport and disposal off site. Photograph taken facing northeast.

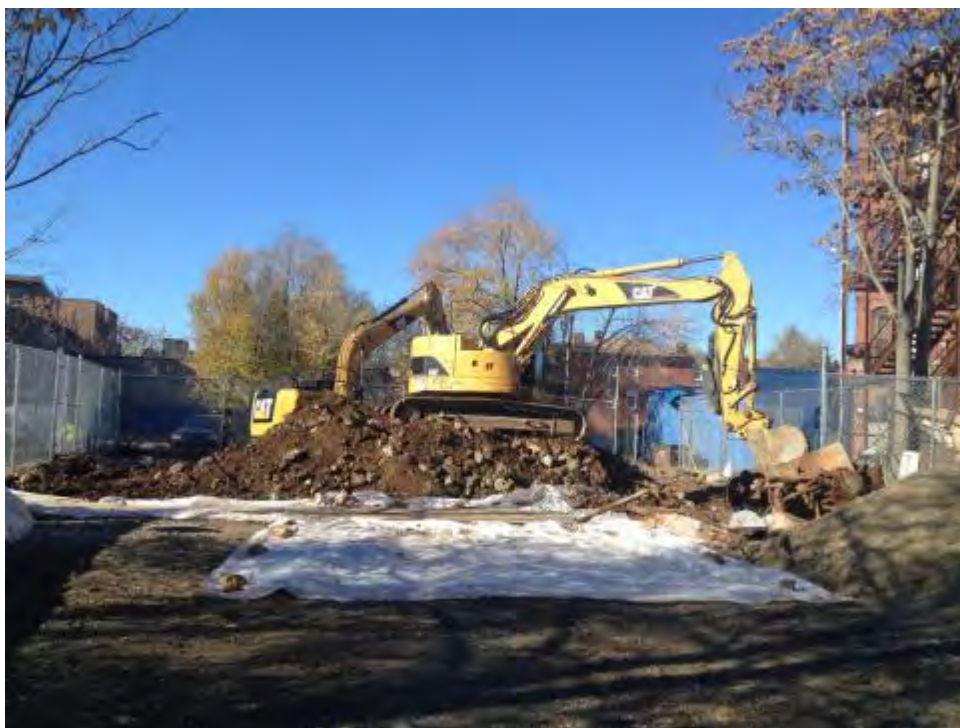
**SCENE:** View of the excavated soil stockpile and scrap metal pile. Photograph taken facing west.

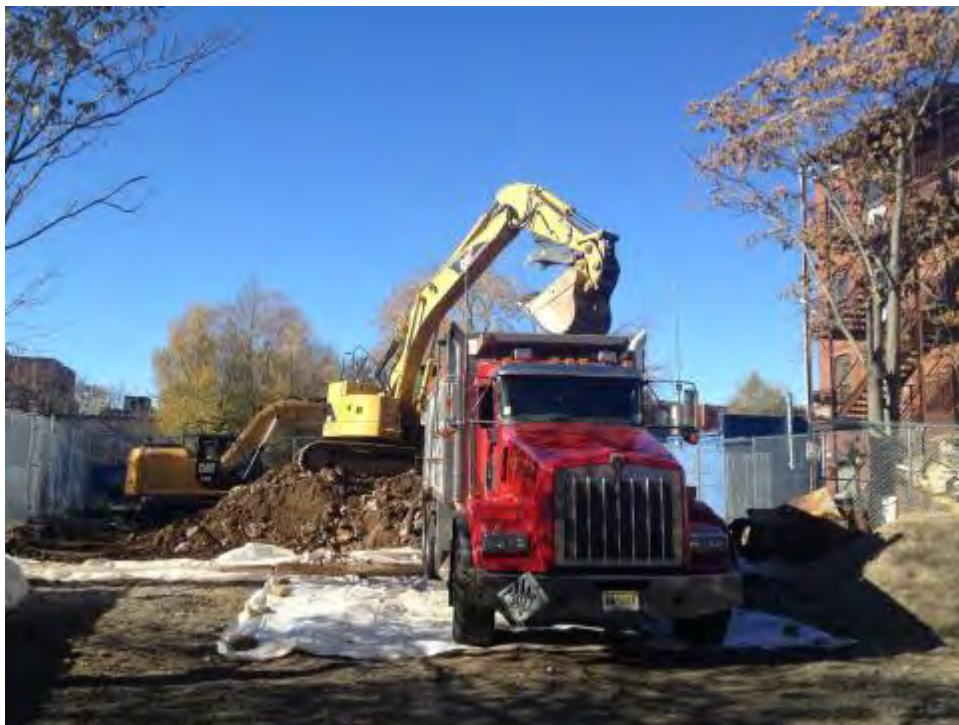
**SCENE:** View of the loading of excavated soil for transport and disposal off site. Photograph taken facing west.

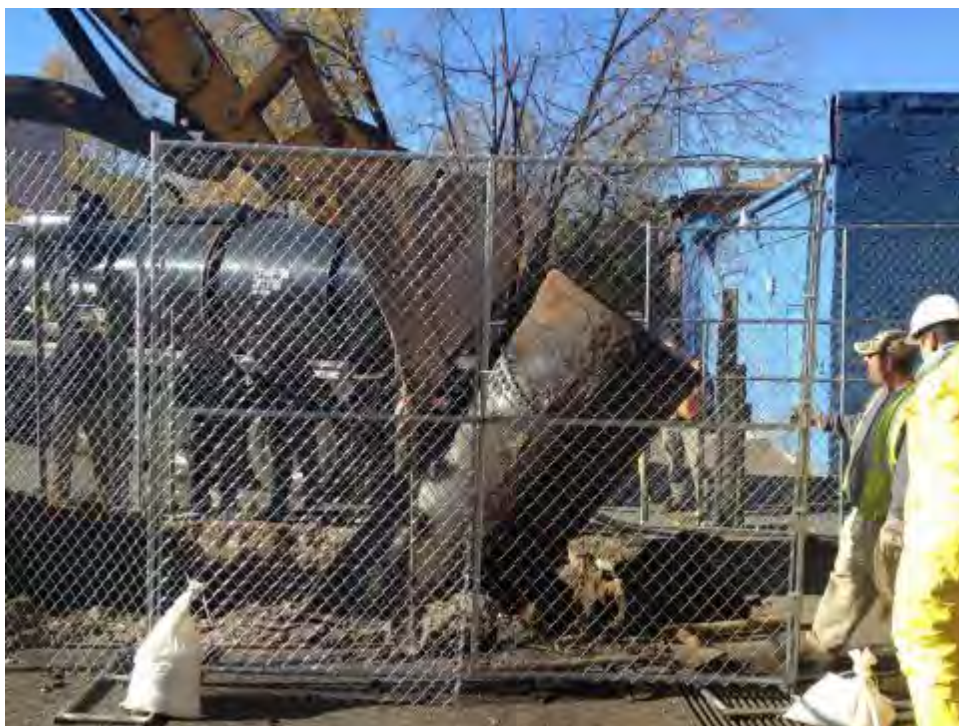
**SCENE:** View of the UST removal. Photograph taken facing west.

On 14 November 2013, CT Hazardous Materials Responder Scalora was on site to supervise the pumping of oil from the UST, and the removal of the UST. A truck from Alpine Environmental was on site to pump 1,142 gallons of oil from the UST. ERRS personnel opened and thoroughly rinsed the inside of the UST using the water tank and sprayer.

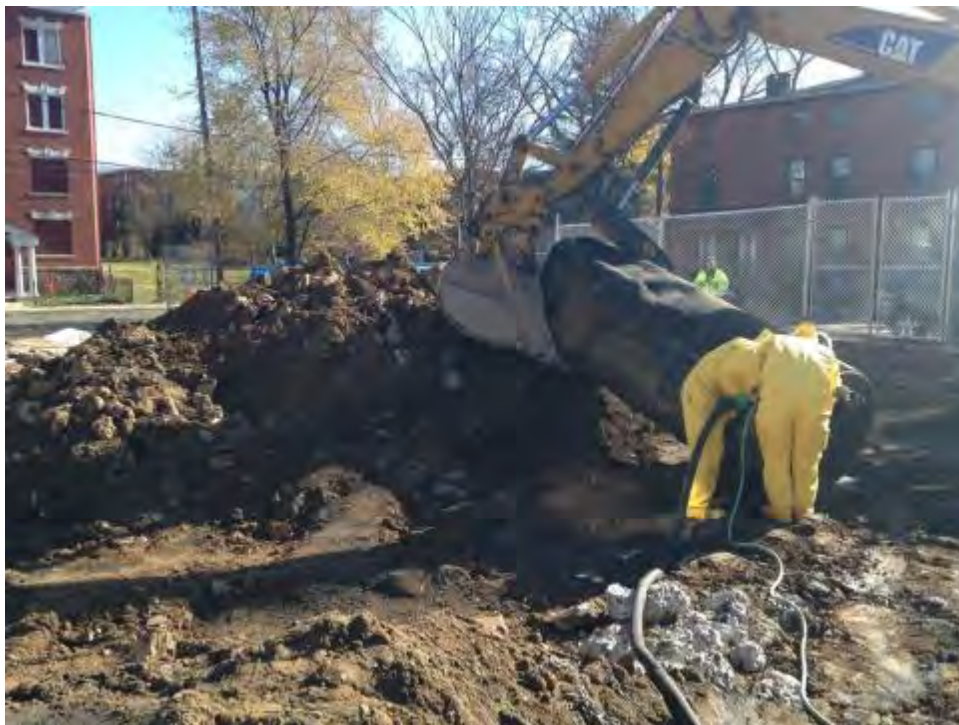
**SCENE:** View of the UST being pumped and rinsed following removal. Photograph taken facing southeast.

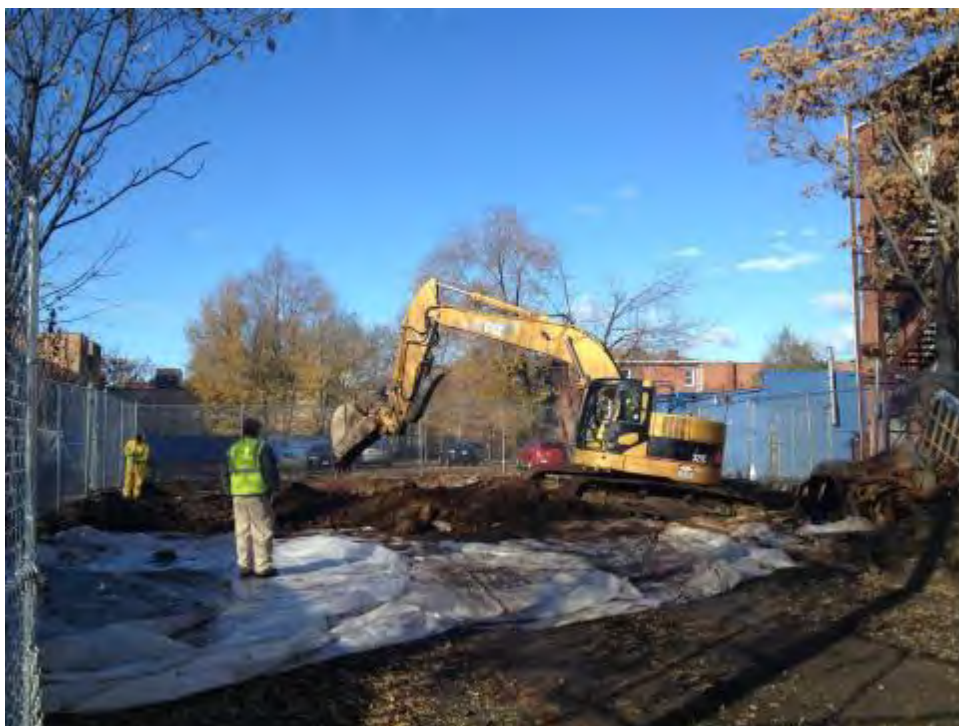
**SCENE:** View of the excavation of contaminated soil. Photograph taken facing west.

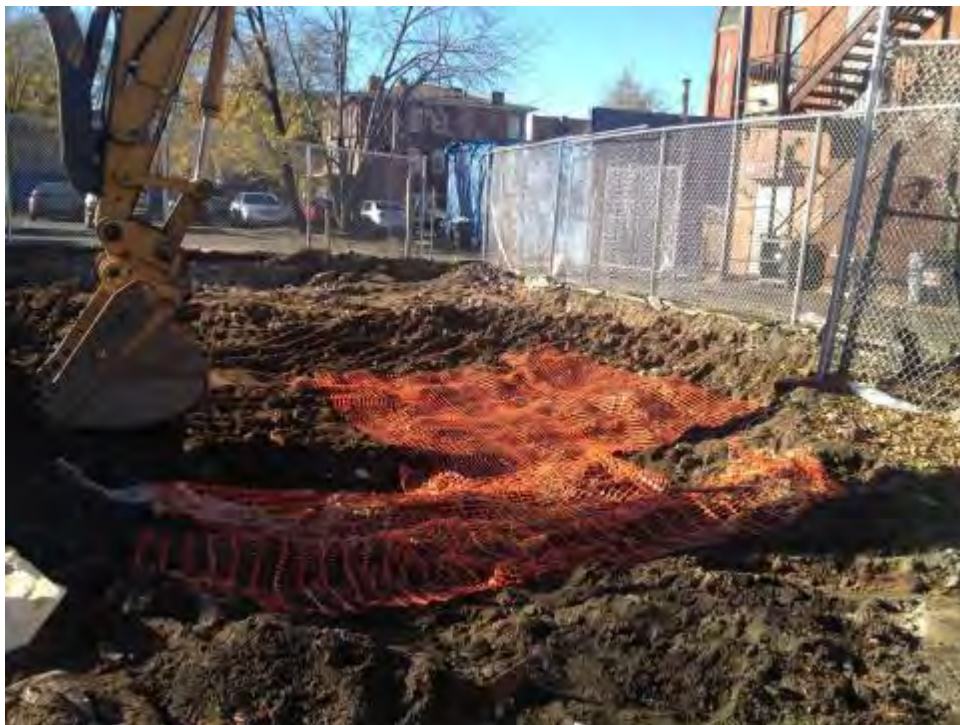
**SCENE:** View of the final excavation grade (3-feet below ground surface) and the demarcation layer (high-visibility plastic fencing). Photograph taken facing northwest.

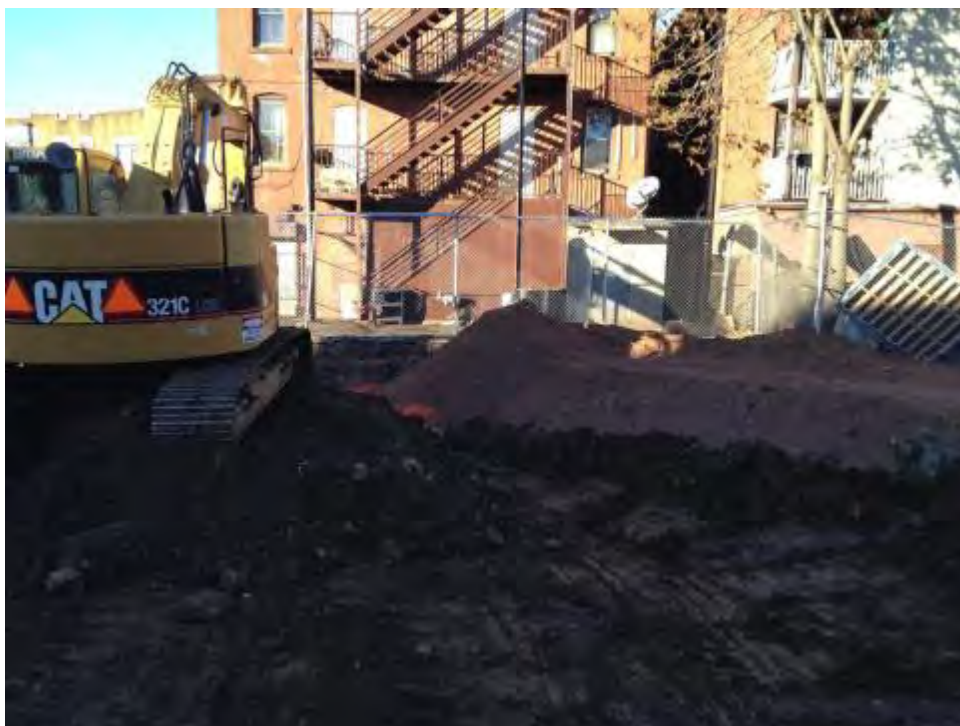
**SCENE:** View of backfilling activities. Photograph taken facing north.

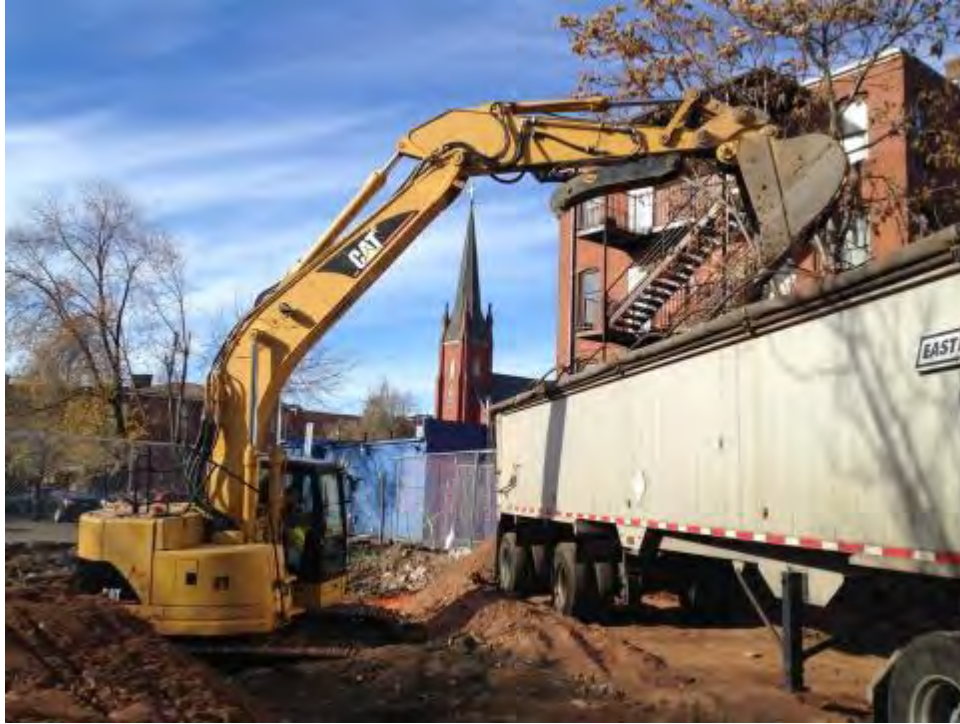
**SCENE:** View of the loading of excavated soil for transport and disposal off site. Photograph taken facing northwest.

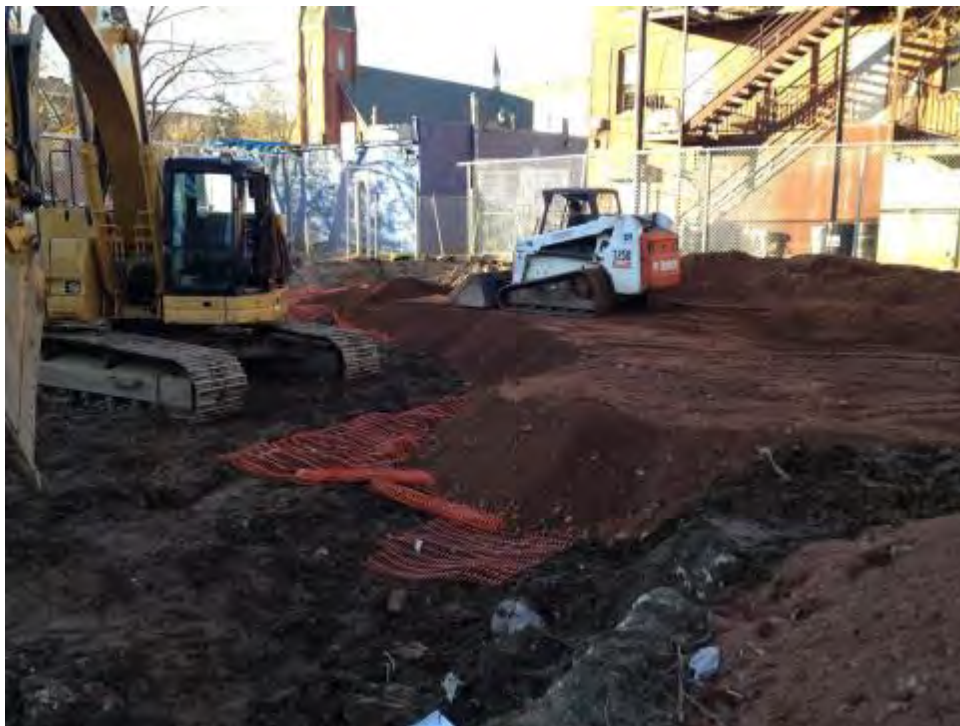
**SCENE:** View of backfilling activities. Photograph taken facing northwest.

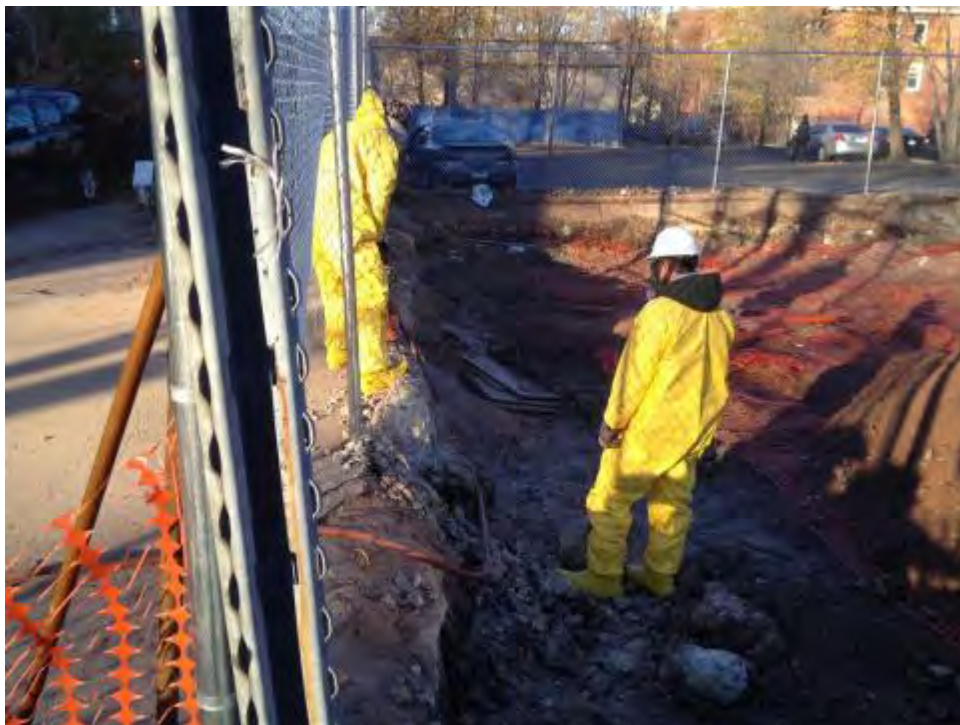
**SCENE:** View of Emergency Rapid Response Services (ERRS) personnel demolishing concrete foundation using an pneumatic hammer. Photograph taken facing west.

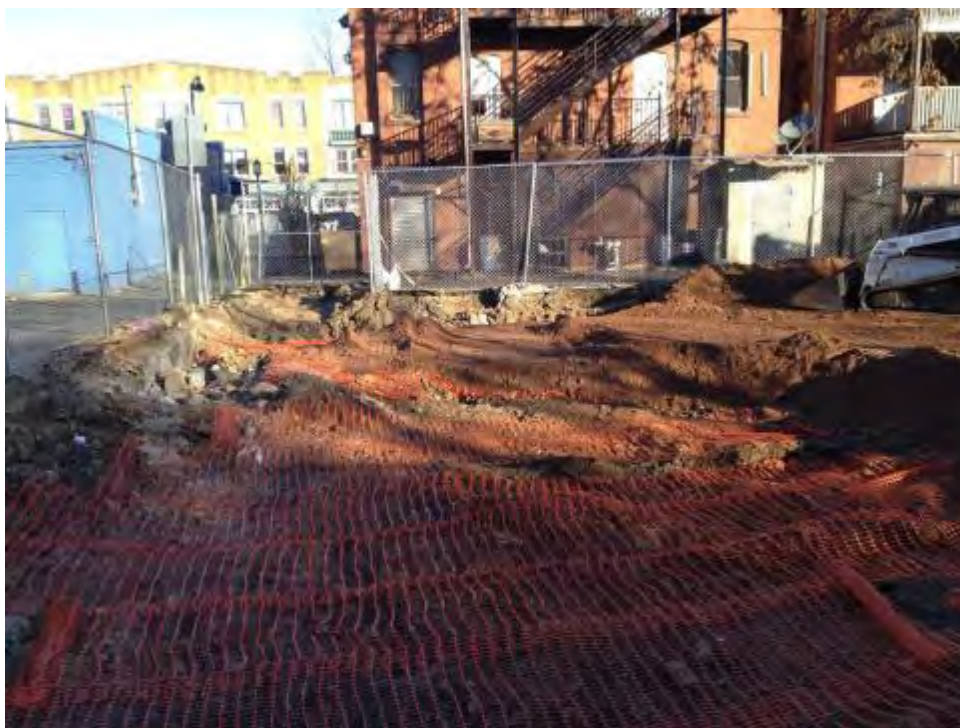
**SCENE:** View of backfilling activities. Photograph taken facing north.

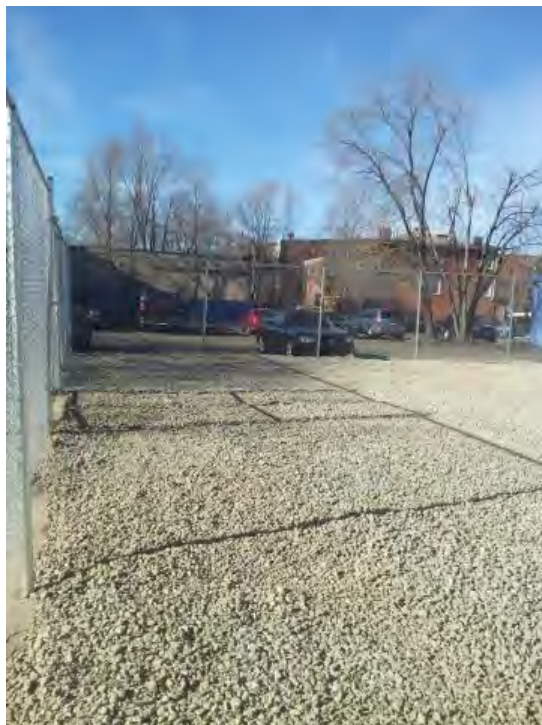
**SCENE:** View of final grading with gravel. Photograph taken facing west.

- Completing the backfilling of the site with fill material (gravel).
- Sweeping the staging parking lot.

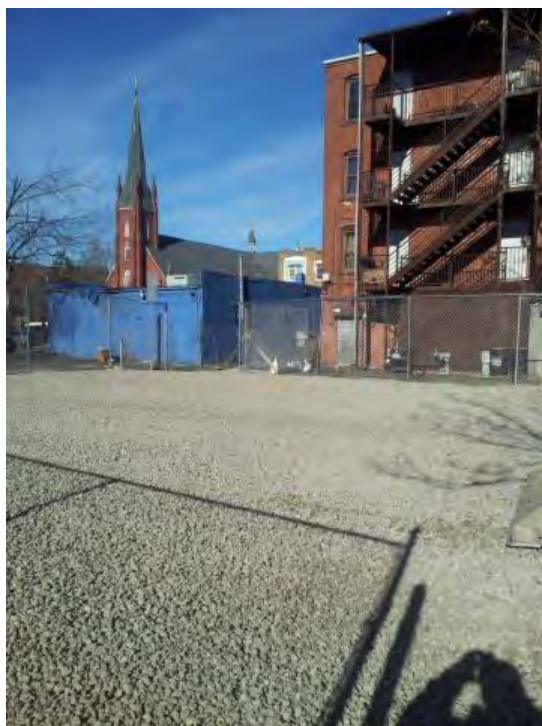
**SCENE:** View of final grading with gravel. Photograph taken facing northwest.

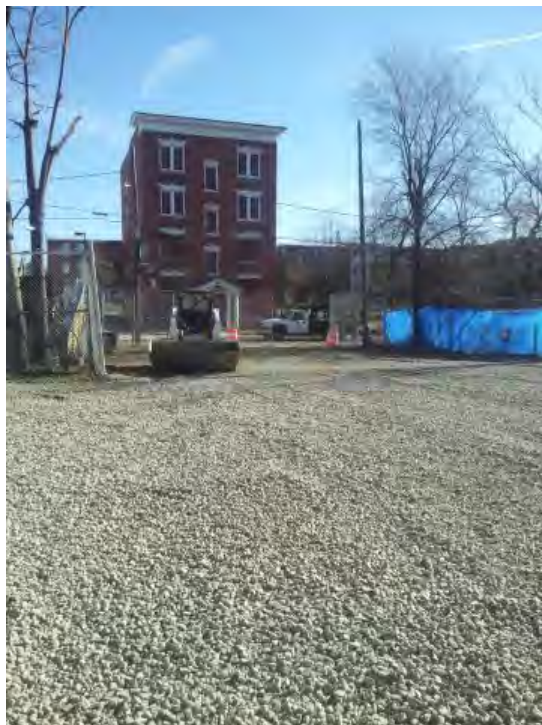
**SCENE:** View of final grading with gravel. Photograph taken facing east.

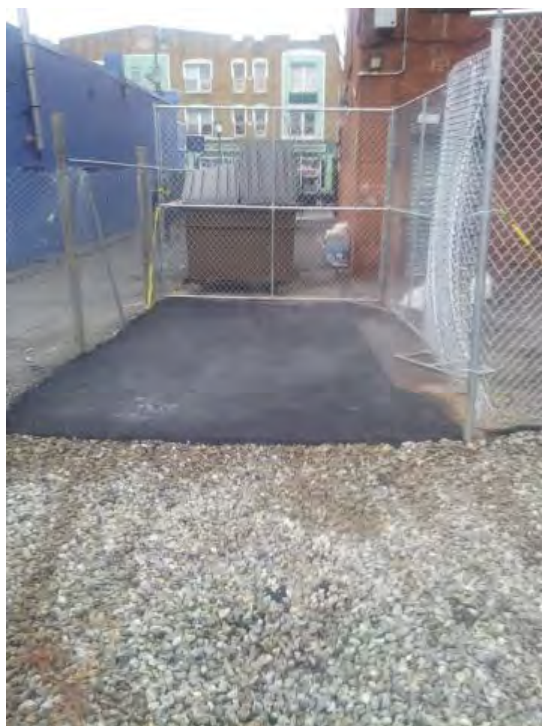
**SCENE:** View of asphalt paving over the former UST location. Photograph taken facing north.

- Installing asphalt over the former UST location.

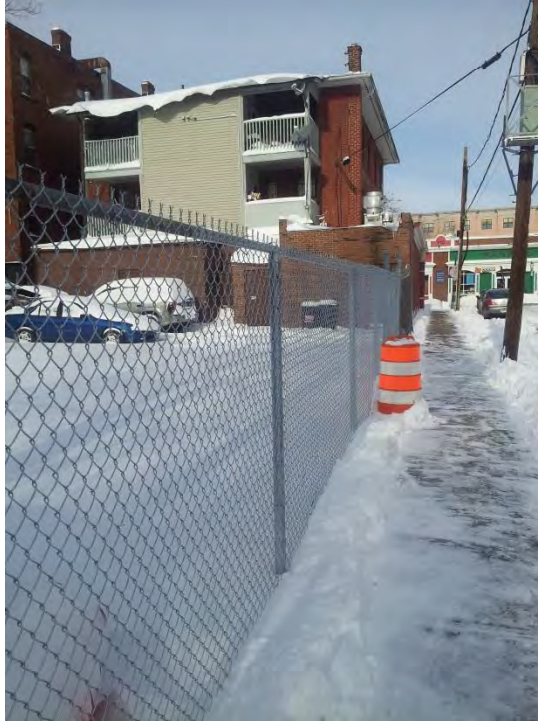
**SCENE:** View of the 6-foot fence along Wolcott Street. Photograph taken facing north.

- Installing fence around the site.

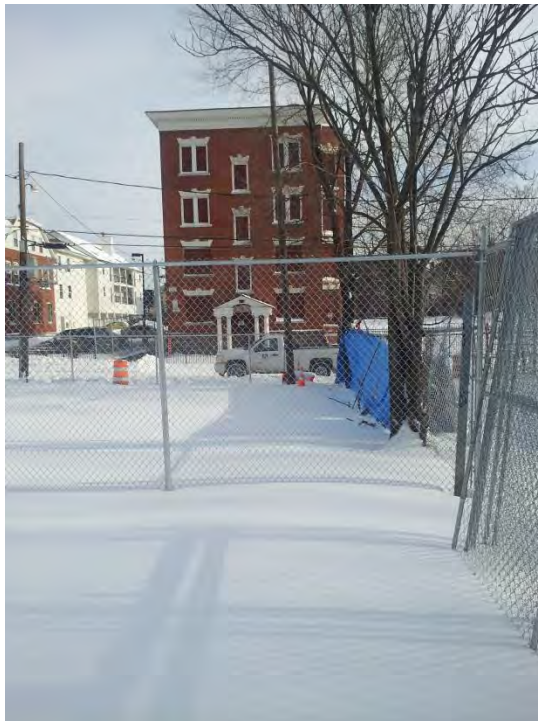
**SCENE:** View of the 8-foot fence moved to the excavation area. Photograph taken facing north.

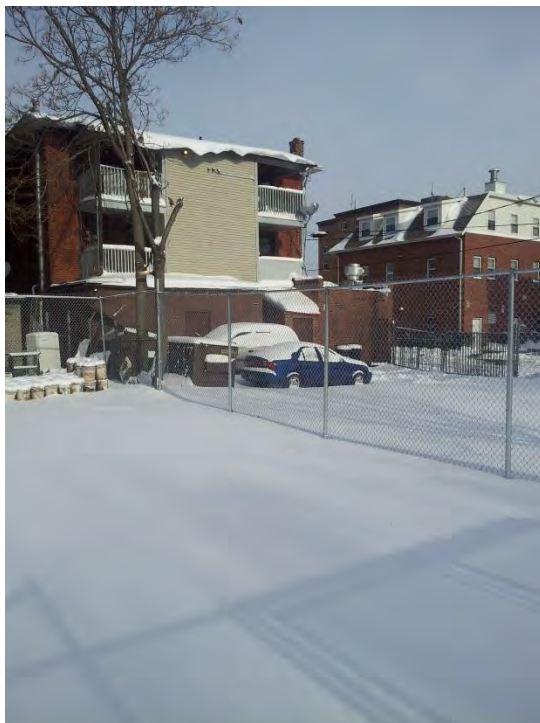
**SCENE:** View of the 8-foot fence with buckets inside the fence. Photograph taken facing northeast.

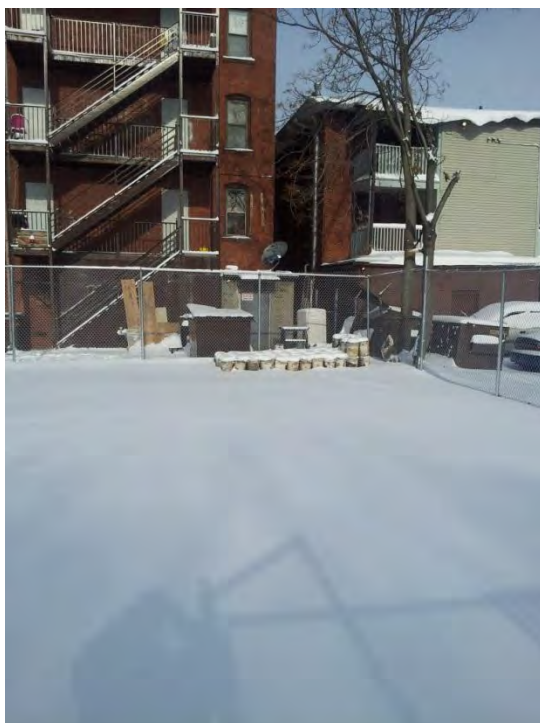
**SCENE:** View of the buckets inside the fence. Photograph taken facing northeast.

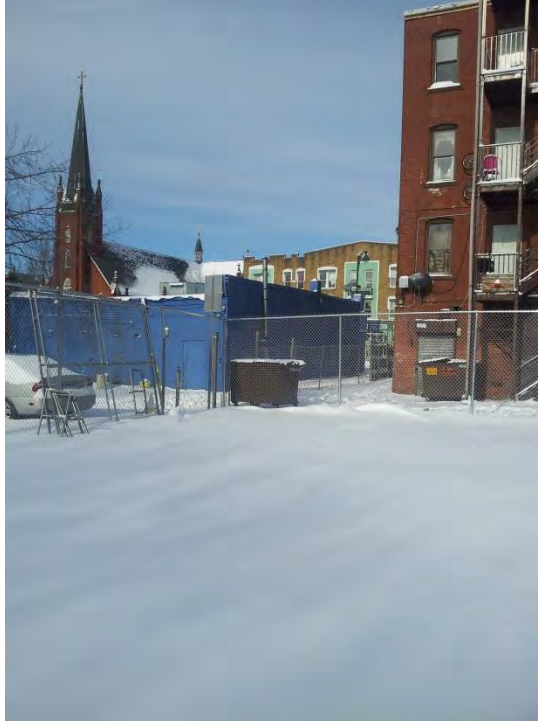
**SCENE:** View of the repaired 8-foot fence following UST removal. Photograph taken facing northwest.

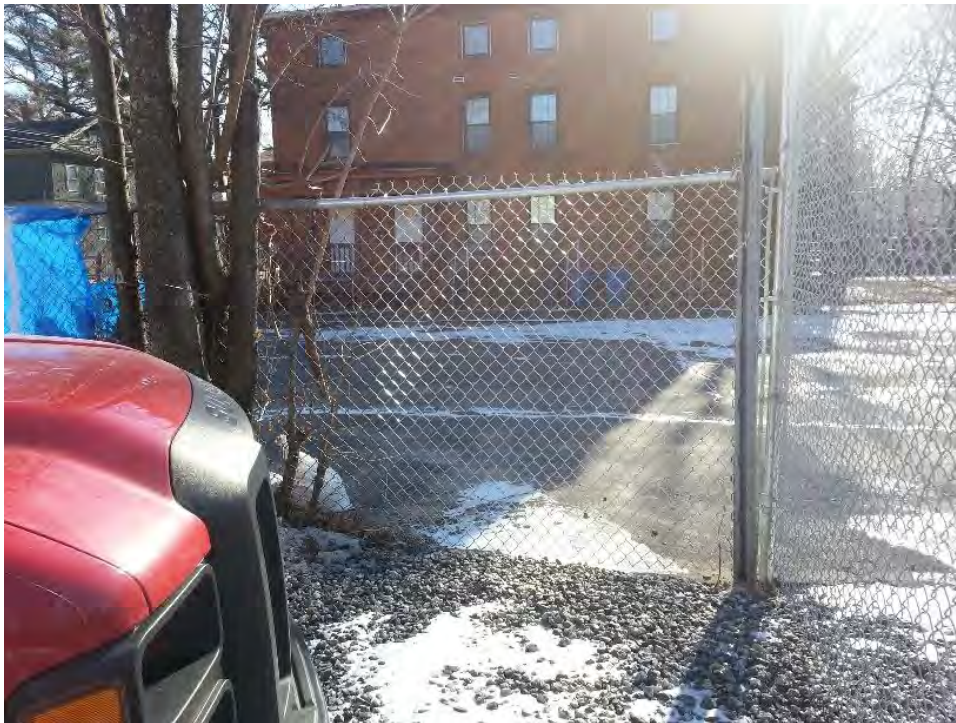
**SCENE:** View of the repaired 6-foot fence in the parking lot. Photograph taken facing east.
